Requalification of Coated Fabrics using Chemlok 2332 in place of Chemlok 233

Department of Chemical and Biomolecular Engineering

Honors Research Project

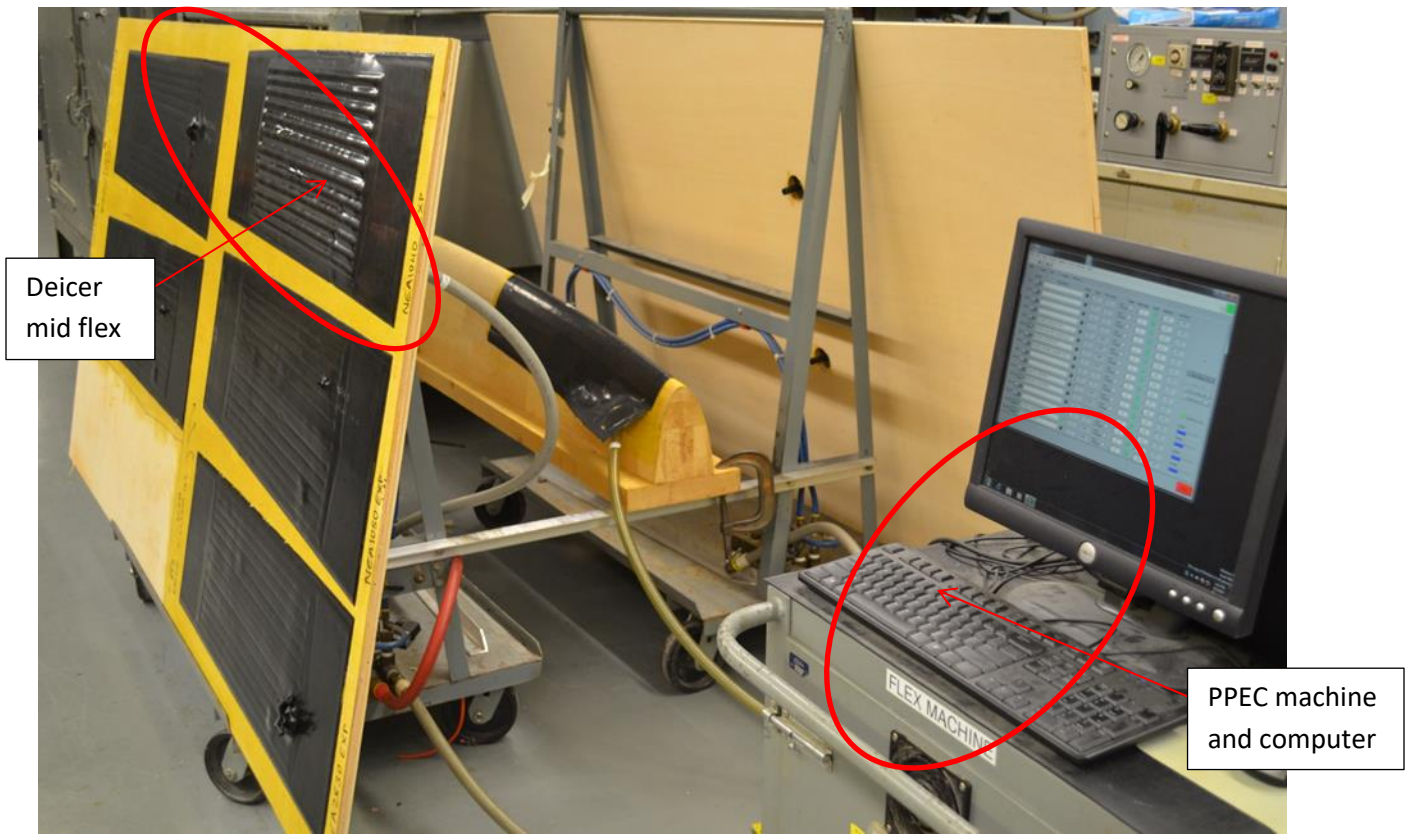
Figure 10 shows the PPEC flex machine. The computer controls the settings for each channel. The deicers are mounted to boards and the top right one is shown mid flex.

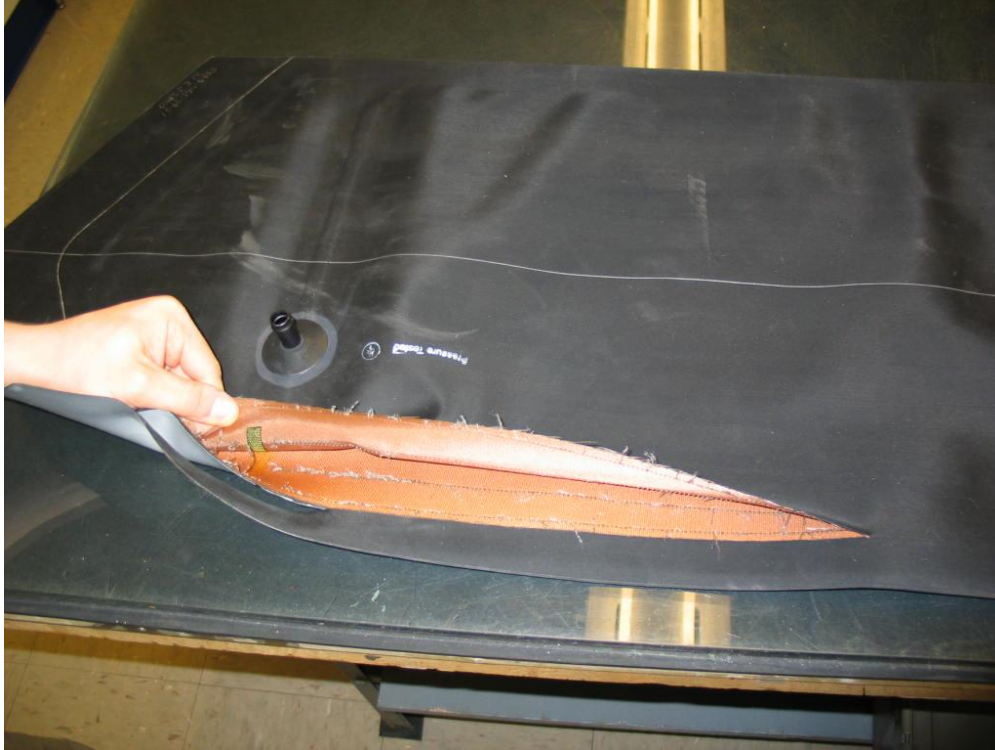
Figure 11 shows Deicer A Burst test bondside failure

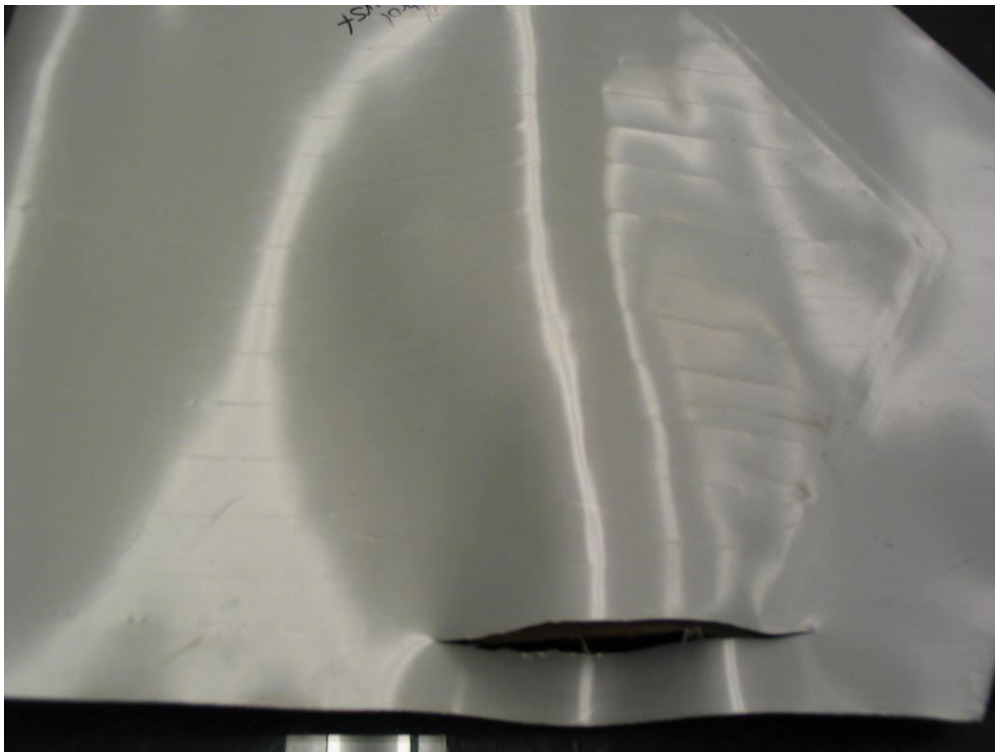
Figure 12 shows Deicer A Burst test breezeside failure

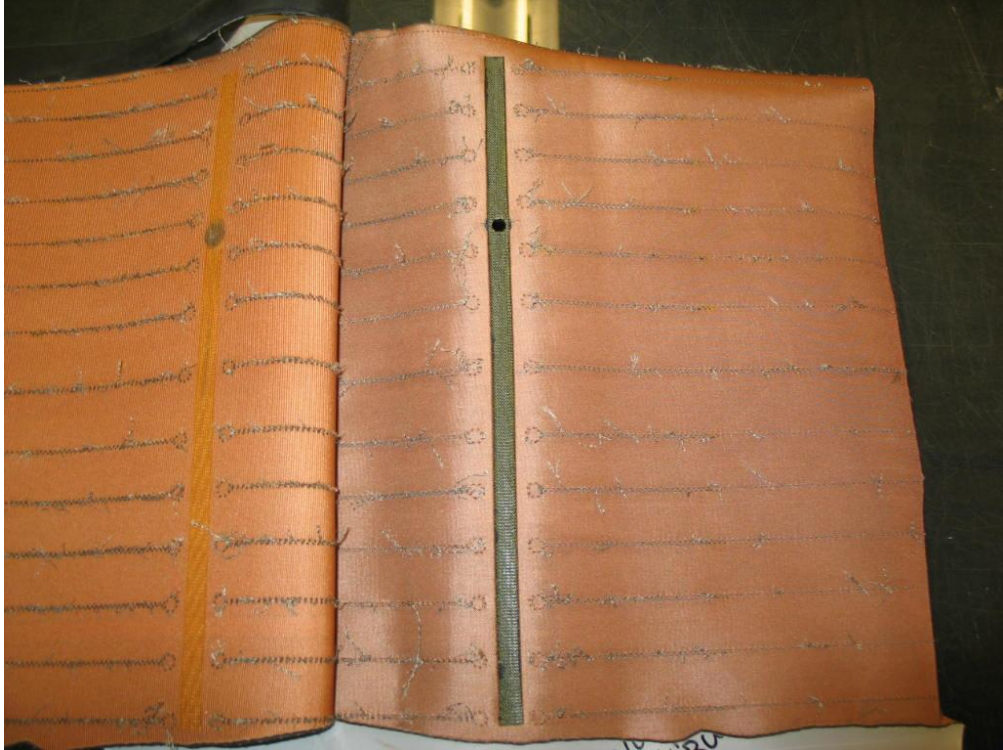
Figure 13 shows Deicer A Burst test manifold inspection

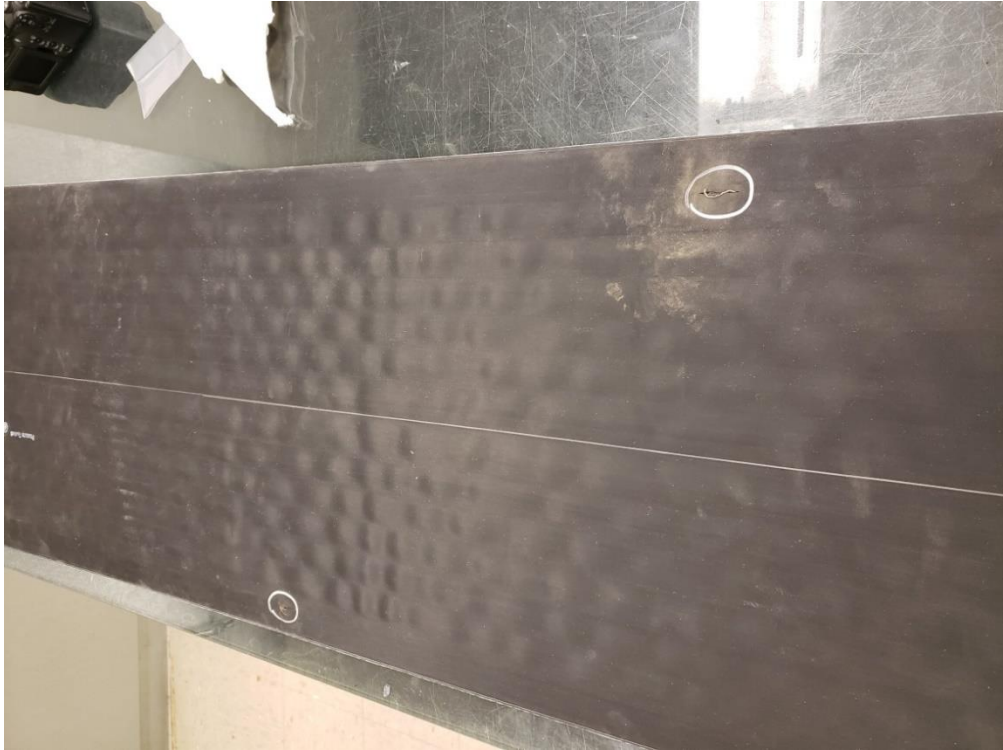
Figure 14 shows Exp Deicer A Burst Bondside failure

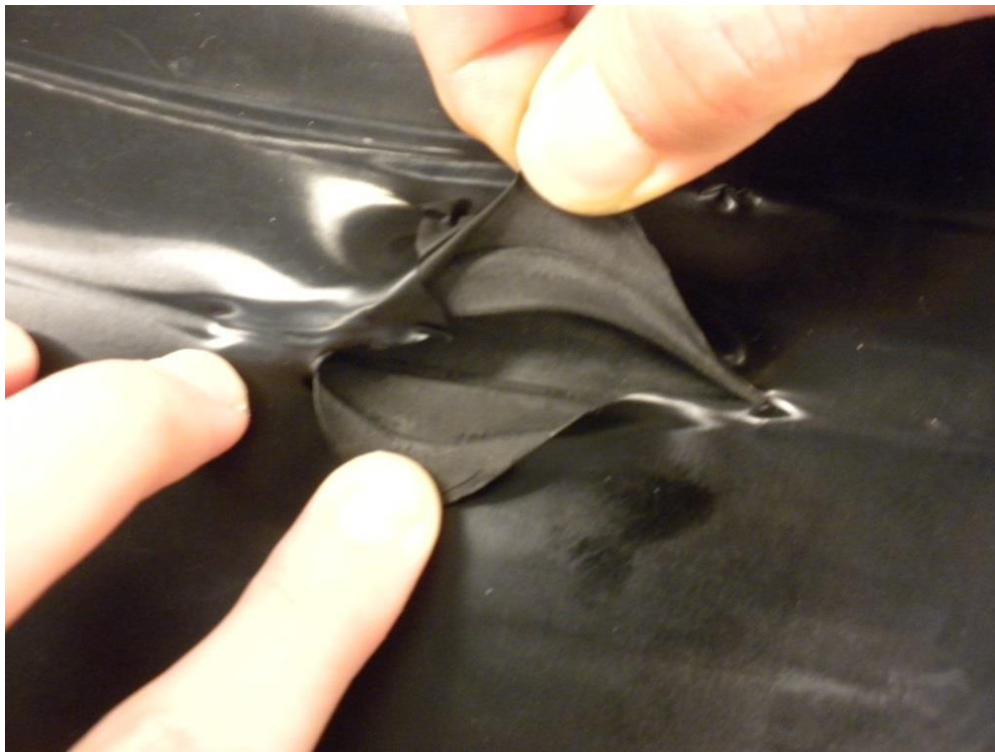
Figure 17 shows Exp B Deicer B 2 cross-inflation inspection.

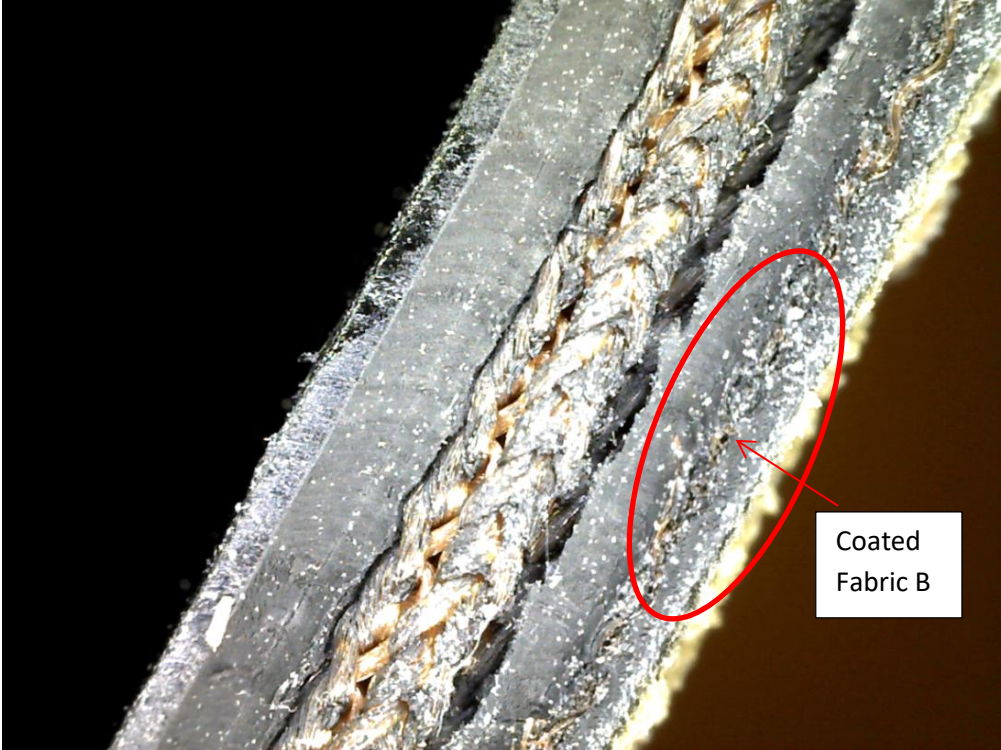
Figure 18 shows Deicer B 1 cross-section. As shown, there is no delamination in the layer containing Coated Fabric B.

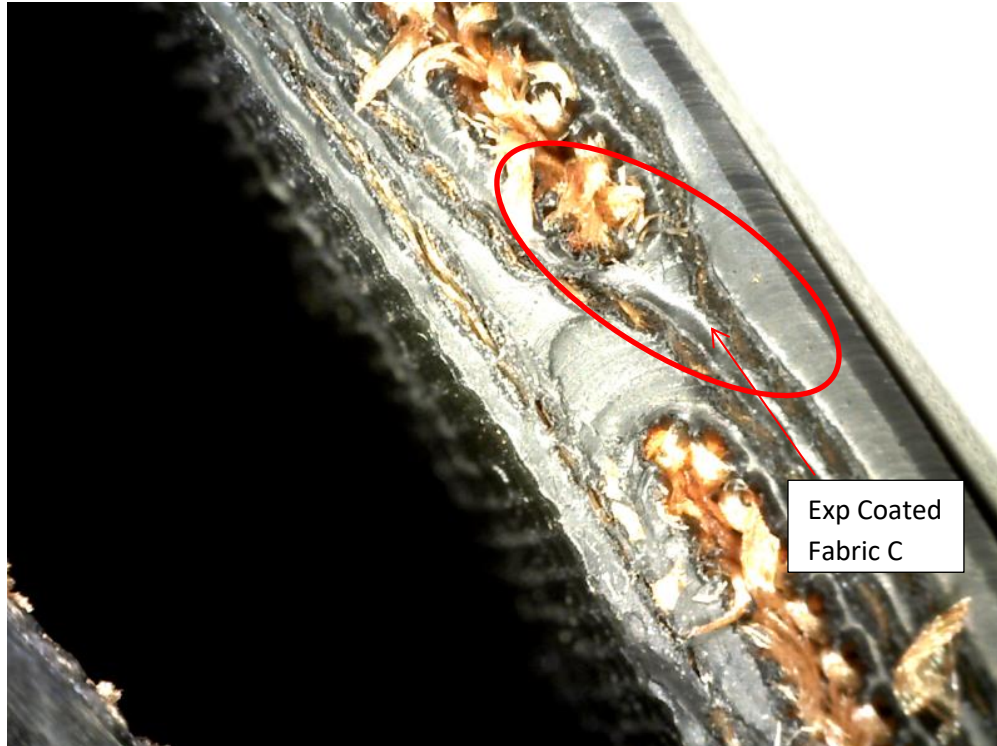
Figure 22 shows Exp C Deicer B 3 cross-section. As shown, there is no delamination in the layer containing Exp Coated Fabric C.

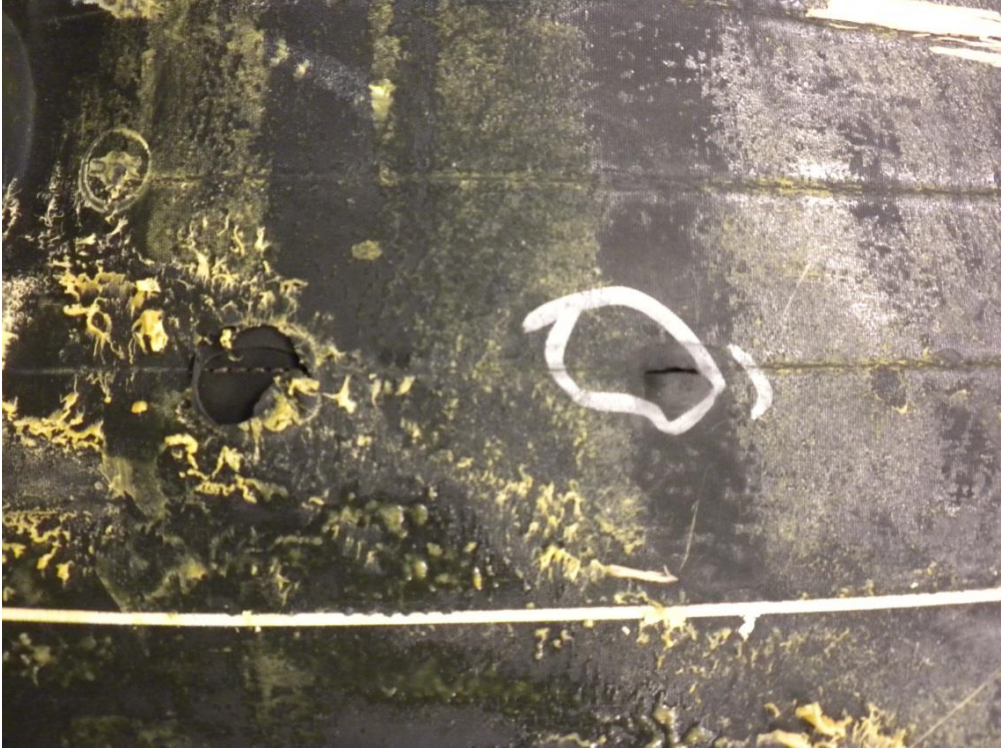
Figure 25 shows Exp B Deicer C 4 bondside failure.

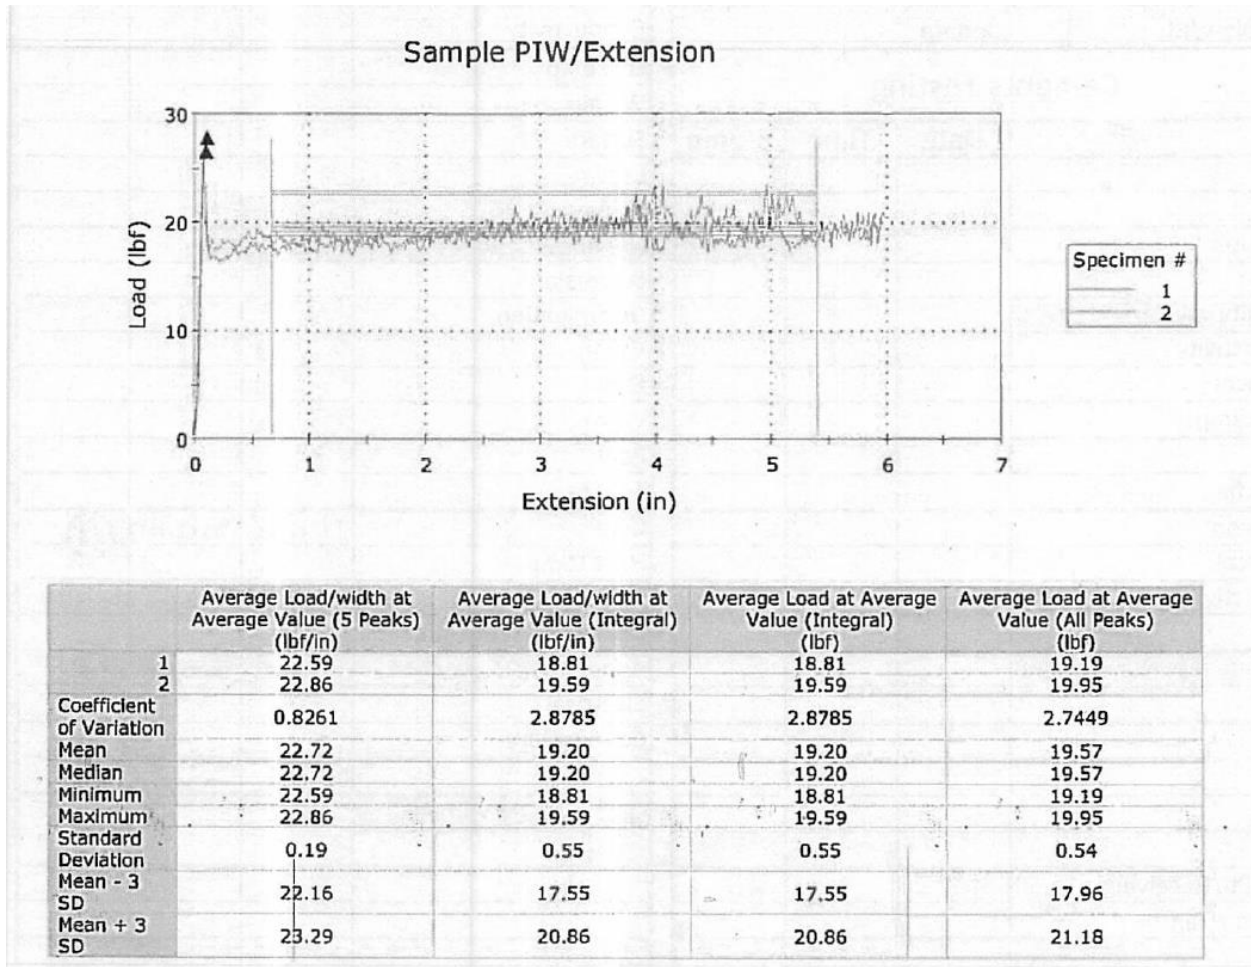
Appendix A: Example of Adhesion Data from Manufacturing Plant in Union, WV.

Figure 29 shows an example of raw adhesion data that would be collected from incoming SP testing at the plant in Union, WV.
