Recent Flooding Events on the Chagrin and Cuyahoga Rivers, Ohio

Honors Thesis

Department of Geosciences, The University of Akron

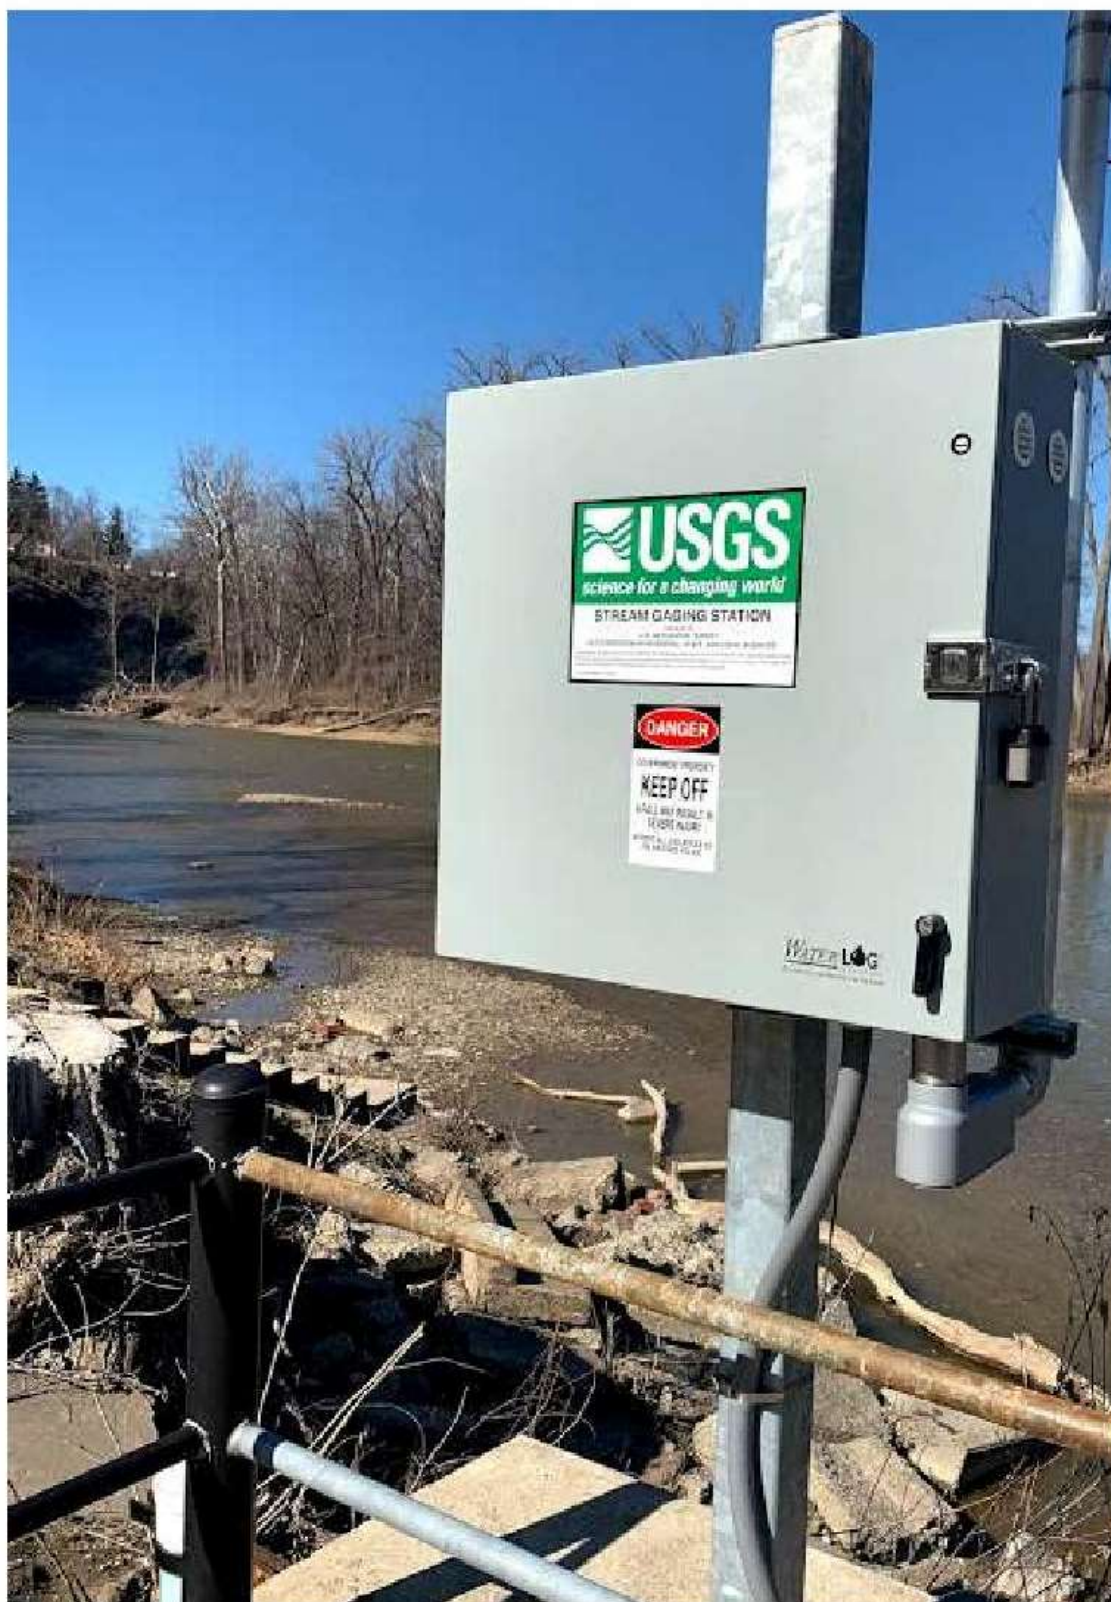
Figure 7. USGS stream gaging station 04209000 on the Chagrin River at Daniels Park in Willoughby, Ohio on March, 2021.

reach the height requirement to be under the jurisdiction of the Ohio Department of Natural Resources (Frischkorn, 2005). The USGS stream gaging station at Willoughby is located downstream of the dam (Figure 7) and after the failure of the dam, there was a large increase in mean daily discharge as the former dam pool emptied (Table 7). January 12, 2005 was the 10th largest flood within the entire record. The high discharge value after the dam failed contributed in small part to the increased mean discharge of the Chagrin River after July 22, 2003. However, the dam failure discharge increase only contributed several weeks to a 17-year post July 2003 record. The remains of the Daniels Park Dam can be seen in the present day (Figure 8).

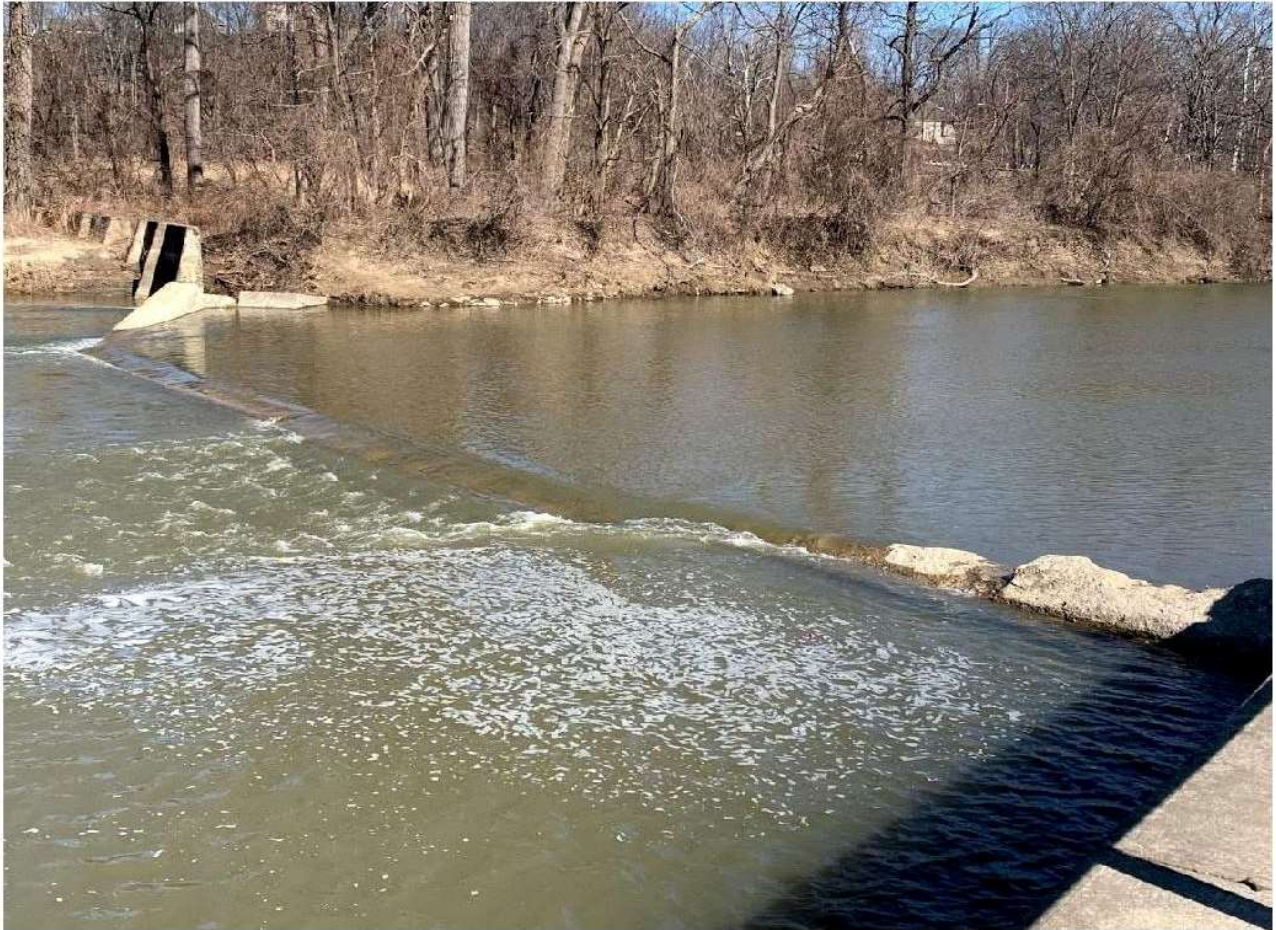
Figure 8. Remains of the Daniels Park Dam on the Chagrin River at Daniels Park in Willoughby, Ohio on March, 2021. The dam failed on 12/31/2004.

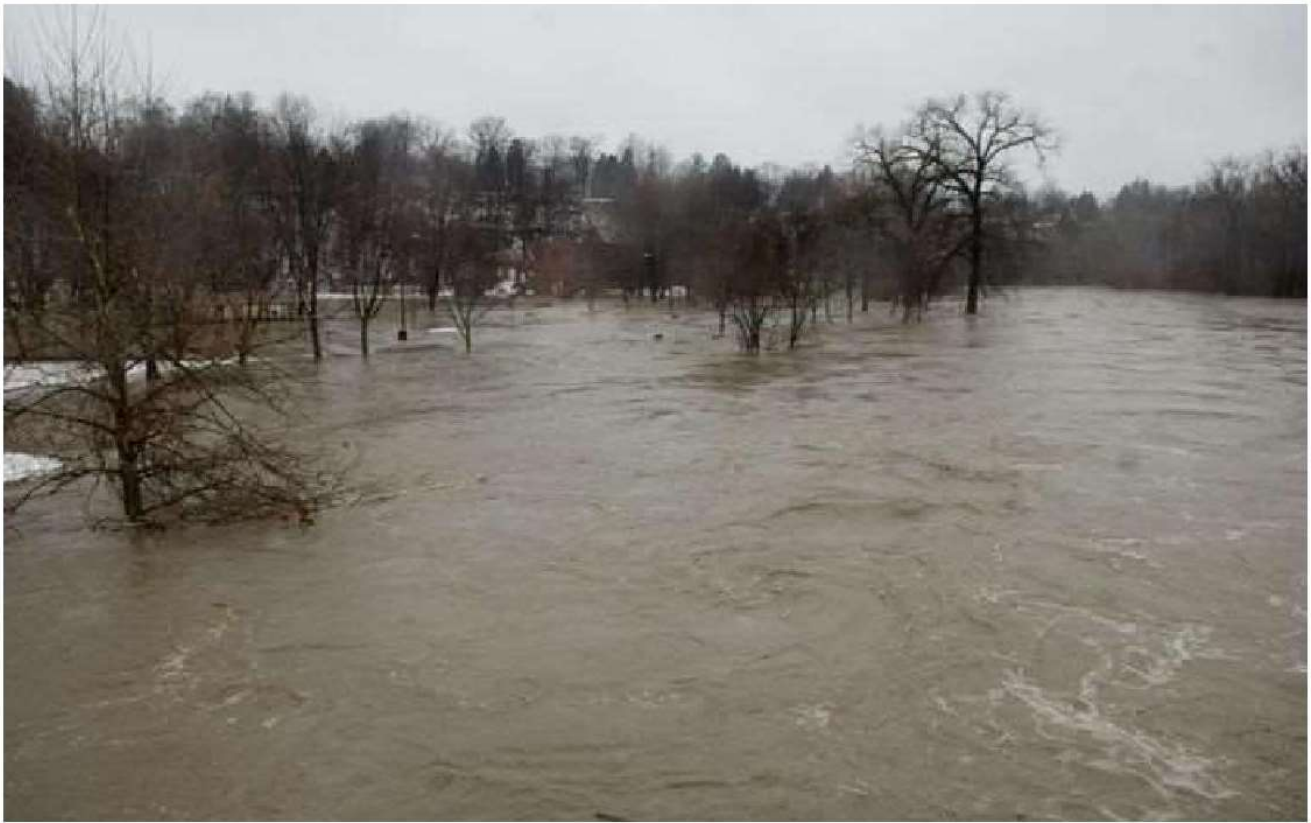
Figure 9. Chagrin River flood at Daniels Park in Willoughby, Ohio February 27, 2011 (Morning Journal, 2011).

In the winter, there is a greater risk of intense flooding (Tables 2, 3, 4, and 5; Figure 3). An intense flood happened at Daniels Park in Willoughby on February 27, 2011 (Morning Journal, 2011)(Figure 9). This flood was caused by the failure of a dam in Gates Mills, located

upstream of Willoughby (Morning Journal, 2011). The failure of this dam added an influx of water to the influx of rain and snowmelt causing it to flood (Morning Journal, 2011). February 28, 2011, the day following the flood, is the 5th highest recorded mean daily discharge of the Chagrin River at Willoughby during the entire record. Despite the high risk of flooding in the winter, there are also intense floods in the summer that should not be ignored (Tables 2, 3, 4, and 5; Figure 3). Yet another event occurred in 2006 when no dam failed. A flood classified as a “500-year flood” occurred in Lake County, Ohio, from July 27 through July 28, 2006, affecting the Chagrin River as well as other rivers in the county (Reardon, 2019)(Figure 10). This flood was caused by torrential rainfall across Northeast Ohio, which had already been inundated by frequent heavy rain earlier in July and in June (Reardon, 2019). Damage in Lake County from this flood cost around \$30 million (Reardon, 2019). Hundreds of people were evacuated and one death was reported (Kropko, 2006). Power outages and sanitation problems were reported after the flood (Kropko, 2006). The mean daily discharge on July 28, 2006 was the 7th highest recorded on the Chagrin River at Willoughby for the entire record. This date was also the highest single-day precipitation event recorded in Chardon for the entire record. Many residents in Lake County can recount the events of this flood, as it affected them and the community greatly (Reardon, 2019; Sadler, 2016).

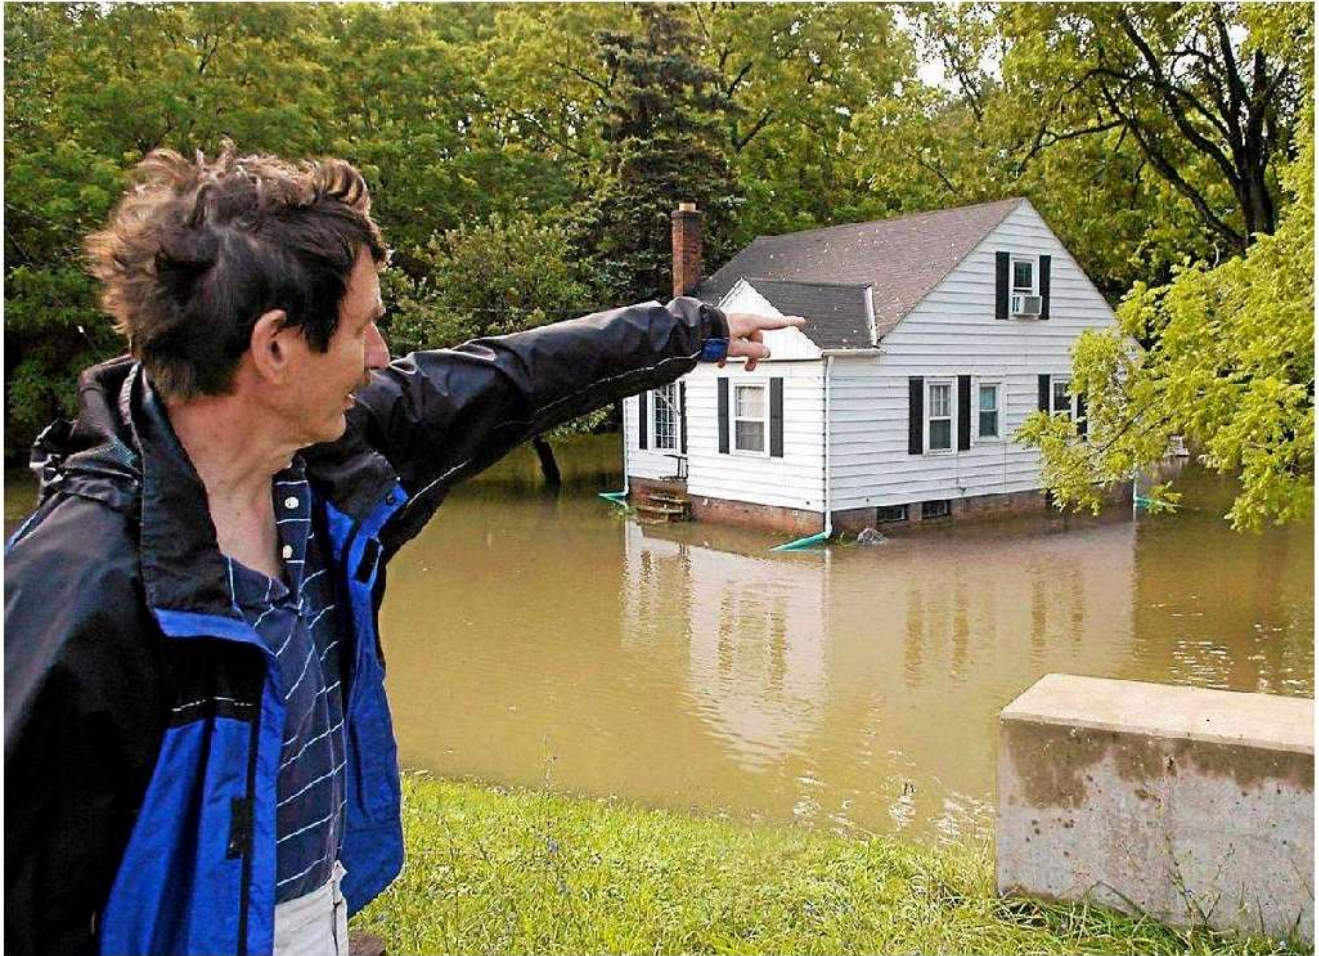
Figure 10. David Moyer, Eastlake resident, showing damage at his house in Eastlake caused by flooding of the Chagrin River July 27-28, 2006 (Sadler, 2016).

previously led to property damage and the loss of homes of many residents (Reardon, 2019; Sadler, 2016). Floods carry contaminated water and other debris that can cause injuries and gastrointestinal illnesses if people are in contact with the contaminated water (U.S. Environmental Protection Agency, 2016). People with disabilities, pregnant women, low-income populations, first responders, and construction workers are at high risk of injury or death caused by flooding (U.S. Environmental Protection Agency, 2018). Heavy precipitation and flooding can damage infrastructure and make traveling on roads more difficult (Angel et al., 2018). Annual flood damage costs in the Midwest are projected to exceed \$500 million by 2050 (Angel et al., 2018).
