A study aimed at characterizing the interfacial structure in a tin–silver solder on nickel-coated copper plate during aging

D C LIN¹, R KOVACEVIC¹, T S SRIVATSAN^{2*} and G X WANG²

Abstract. This paper highlights the interfacial structure of tin-silver (Sn-3.5Ag) solder on nickel-coated copper pads during aging performance studies at a temperature of 150°C for up to 96 h. Experimental results revealed the as-solidified solder bump made from using the lead-free solder (Sn-3.5Ag) exhibited or showed a thin layer of the tin–nickel–copper intermetallic compound (IMC) at the solder/substrate interface. This includes a sub-layer having a planar structure immediately adjacent to the Ni-coating and a blocky structure on the inside of the solder. Aging performance studies revealed the thickness of both the IMC layer and the sub-layer, having a planar structure, to increase with an increase in aging time. The observed increase was essentially non-linear. Fine microscopic cracks were observed to occur at the interfaces of the planar sub-layer and the block sub-layer.

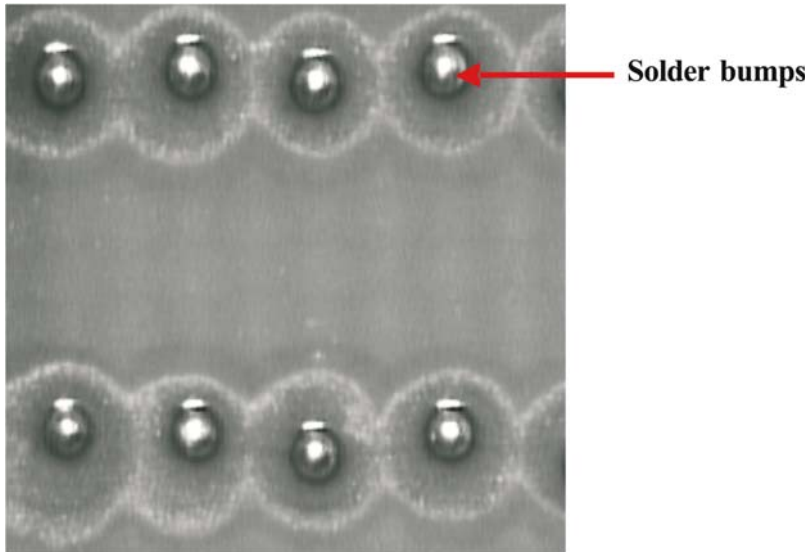
Figure 1. An overhead view of the solder bumps on a printed-circuit (PC) board.

(f) The as-solidified solder bump is shown in figure 1.

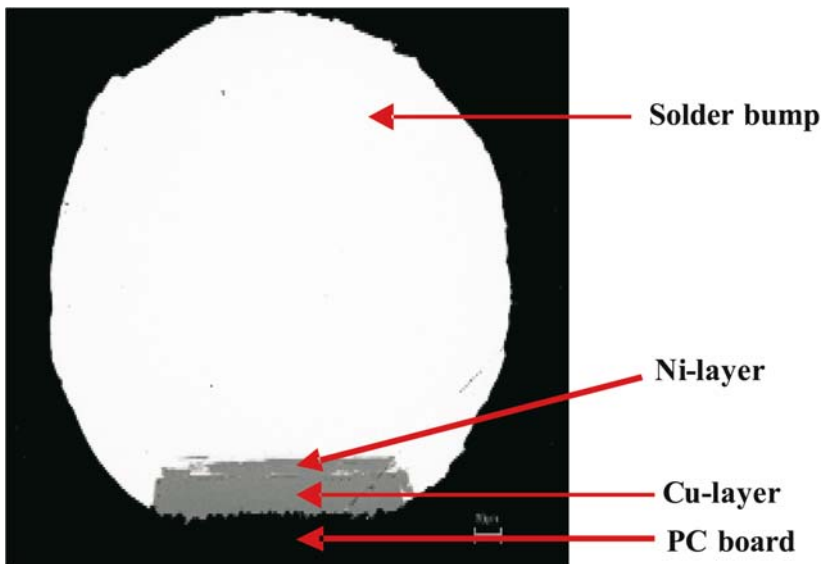
Figure 2. Cross-section view of a single solder bump.

A typical cross section of an as-solidified solder bump is shown in figure 2. The magnified details at the interface between the solder and substrate of the nickel-coated copper pads are shown in figure 3. In figure 3a backscattered electron micrograph is shown, taken at the solder/substrate interface. Figure 3b reveals the distribution of key elements in the nickel-layer through EDS analysis using the point mode technique. Figure 3c reveals the key elements in the copper-layer while figure 3d is an EDS of the Sn–Cu–Ni compound. The distribution of key elements was obtained using the attached X-ray detector with analysis made possible using the EDAX software. The elements present in the various layers are summarised in table 1.

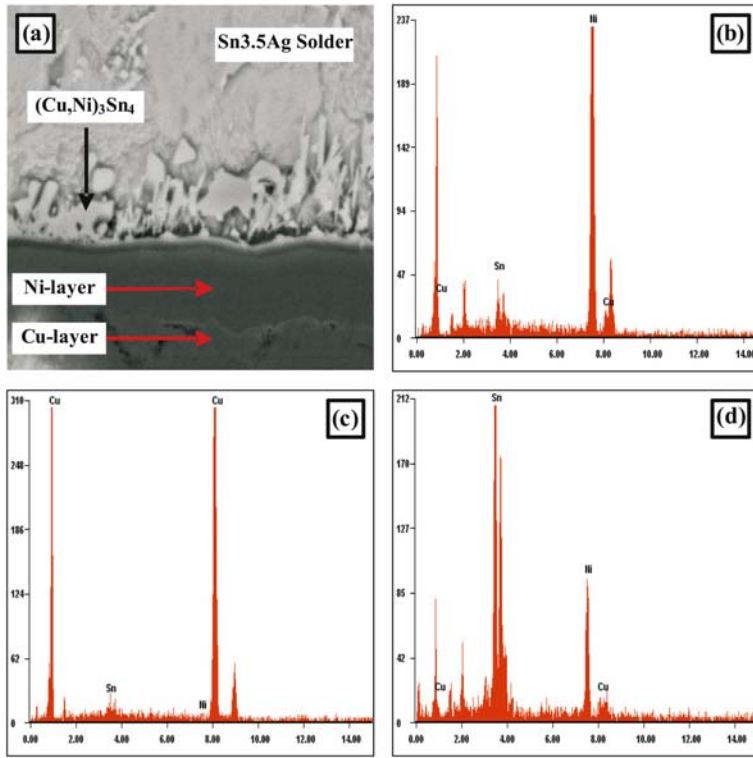
Figure 3. Backscattered SEM image and EDS analysis for the Sn3.5Ag solder bump. (a) Interfacial structure, (b) EDS map of the nickel layer, (c) EDS map of the copper layer, (d) EDS map of the Sn–Ni–Cu compounds.

From both figure 3 and table 1, it is observed that the composition of the Ni-layer shows a distribution of 91.08% Ni, 4.17% Sn and 4.75% Cu. Further, in this layer, both tin and copper are believed to come from the neighbouring solder and the copper-layer. In the copper-layer, the EDS analysis shown in figure 3c reveals a distribution of 96.07% Cu, 1.24% Ni, and 2.69% Sn. Further, in this layer the nickel and tin are believed to come from the neighbouring nickel layer and the solder by way of diffusion. On the solder side, i.e. near the solder/substrate interface, EDS analysis revealed (figure 3d) a distribution of 60.86% Sn, 33.72% Ni, and 5.42% Cu. This indicates the presence of the Sn–Ni–Cu ternary phase at the interface. This was identified to be the $(\text{Ni}_x\text{Cu}_y)_3\text{Sn}_4$ in the published literature (Kang *et al* 2002).

The morphology at the interface shown in figure 3a is not characterized by the presence of scallop-like Sn–Cu intermetallic compounds (Chuang *et al* 2004). It includes two sub-layers: (i) A planar looking Sn–Ni–Cu sub-layer, which is adjacent to the nickel layer. (ii) A blocky looking Sn–Ni–Cu sub-layer, which is immediately adjacent to the solder.

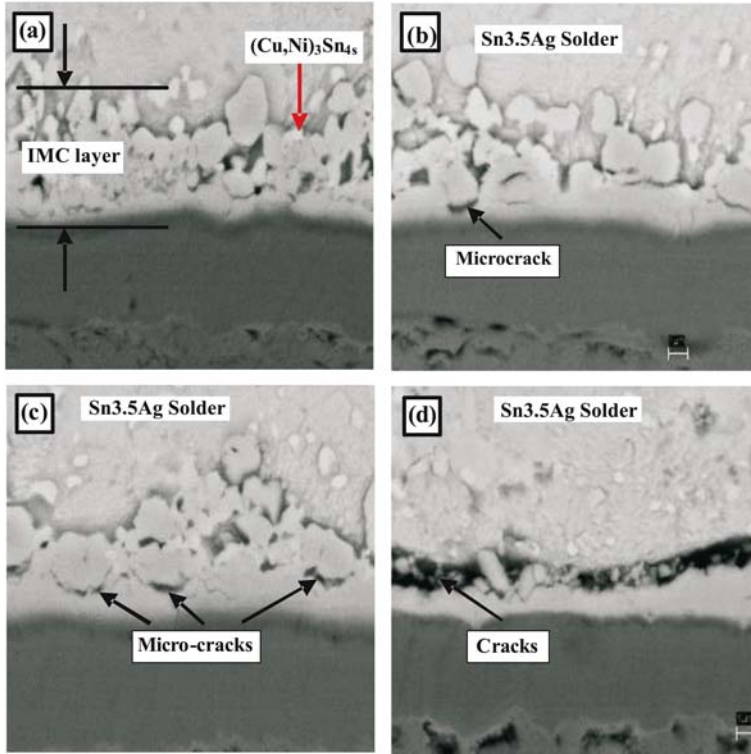
Figure 4. Backscattered scanning electron micrographs showing the interfacial structure when subjected to various aging times: (a) 24 h, (b) 48 h, (c) 72 h and (d) 96 h.

The microstructure of the Sn3.5Ag solder bumps on subjecting to a thermal aging treatment at 150°C is shown in figure 4. The interfacial structure following 24 h treatment is as shown in figure 4a. To quantify the influence of aging time on microstructure, the thickness of the IMC is measured using the definition shown in figure 3a. The thickness of the IMC was 4 microns (μm) following exposure to the temperature for 24 h and is shown in figure 4a. The thickness of the IMC was 2.8 microns (μm) for the as-solidified case and is shown in figure 3a. Results using the same measurement technique for the other coupons that were aged for 48 h (figure 4b); for 72 h (figure 4c), and for 96 h (figure 4d) are summarised in table 2. The variation of thickness of the IMC as a function of aging time is shown in figure 5. It is observed that the thickness of the IMC increases with an increase in aging time at temperature. Further, it was observed that the highest increase in the thickness of the IMC occurred during the first day or 24 h of aging at the chosen temperature. Following the initial increase there occurs a reduced rate of increase in the thickness of the IMC. After a certain time interval of exposure, the thickness of the IMC cannot increase any further since both microscopic cracks (figure 6a) and macroscopic cracks (figure 6b) appear at the solder/substrate interface.

Further, it is seen from figure 4 that the microscopic cracks in the samples that occurred in a region between the planar Sn–Ni–Cu sub-layer and blocky-like non-planar sub-layer of Sn–Ni–Cu, in particular at the root of the blocky sub-layer (see figure 6). The overall thickness of the planar Sn–Ni–Cu sub-layer, measured from figure 3a, figure 4a, figure 4b, figure 4c, and figure 4d, increases with an increase in aging time as summarised in table 3 and shown in figure 7. It was found that the thickness of the planar sub-layer and the whole or entire IMC layer, as a function of aging time at temperature of 150°C, increases with time of exposure to temperature. The macroscopic cracks occurred upon exposing the solder bumps to the high temperature environment 150°C for 96 h aging and are conveniently located along the boundary line, which separates the planar-like and the blocky-like Sn–Ni–Cu intermetallic compound.

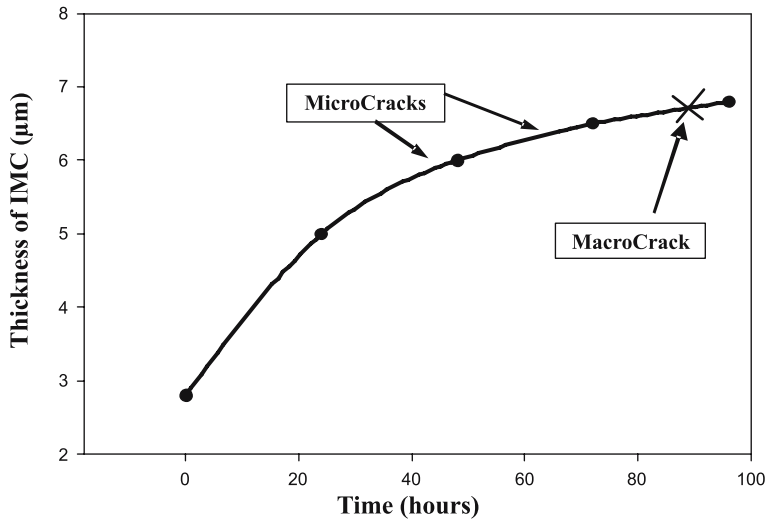
Figure 5. The variation of thickness of the IMC layer as a function of aging time.

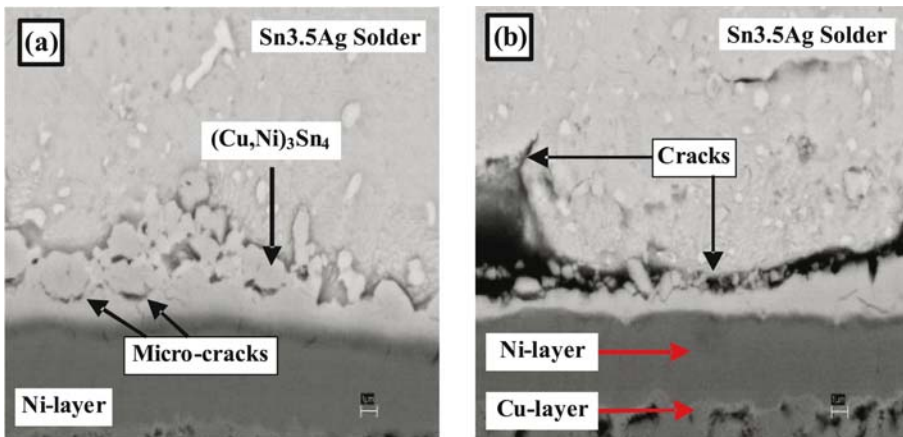
Figure 6. Scanning electron micrographs identifying the presence and location of the: (a) microscopic cracks, and (b) macroscopic crack.

The presence of fine microscopic cracks along the grain boundaries is caused by a gradual accumulation of stress and resultant strain during aging at the higher temperature. Further, a noticeable difference in the thermal expansion coefficient of the various layers, i.e. copper, nickel and solder causes the microstructure of the Sn–Ag solder that was subjected to aging

at 150°C for 96 h reveals a transformation of the microscopic cracks to macroscopic cracks to occur along the boundary line of the blocky-like compounds and the planar-like looking compounds.

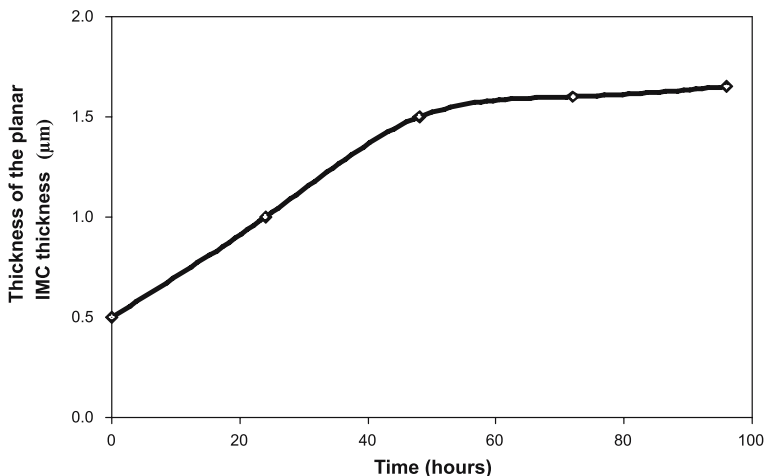
**Figure 7.** Variation of the thickness of the planar Sn–Ni–Cu layer with aging time (hours).
